A MASTER PLAN FOR THE MONUMENT-BERRYMAN COMMUNITY

PREPARED FOR THE CITY OF DANVILLE, VIRGINIA
BY COMMUNITY PLANNING PARTNERS, INC.
JANUARY, 2014

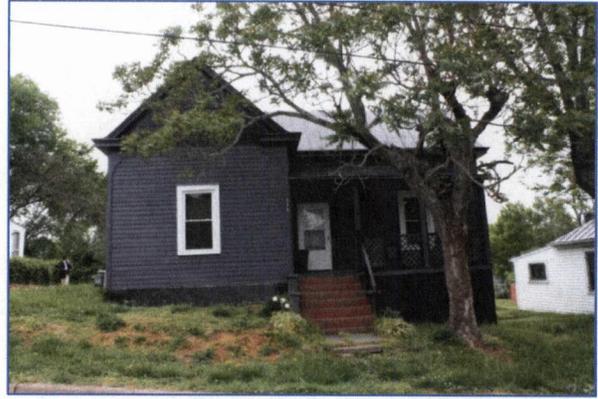
**Carpenter Gothic with single Front Gable
538 Franklin St.**

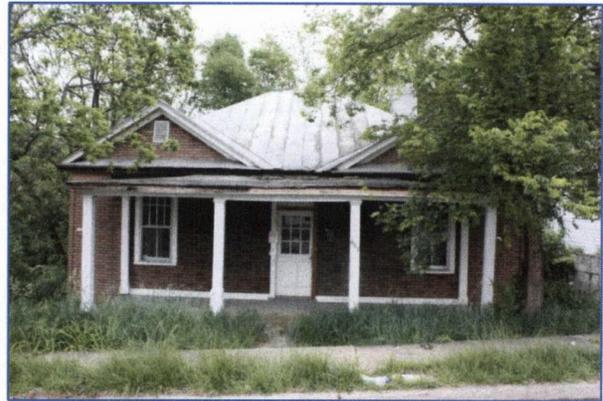
**Carpenter Gothic with double Front Gables
687 Shelton St.**

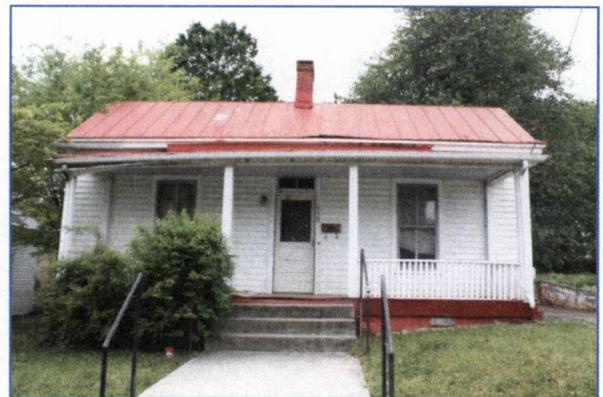
**Carpenter Gothic with Side Gables
513 Cabell St.**

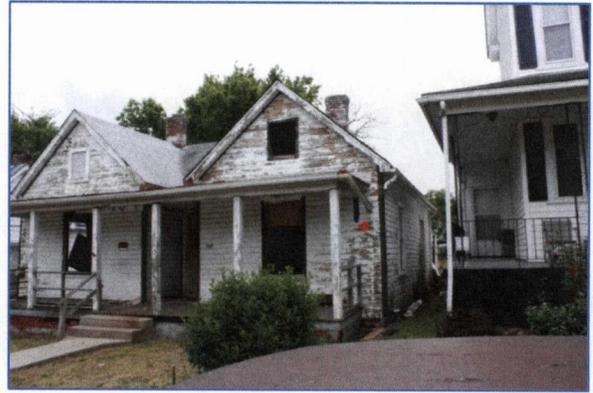
527 Cabell Street

Three examples show the extent of this disinvestment. The property owner of 527 Cabell St. (shown above) had begun rehabilitating the house as evidenced by some new floor joists installed at the rear of the building, but instead, chose to walk away from the property. Left in its current state, the building continues to deteriorate, much to the detriment of the adjacent property owner who is obviously

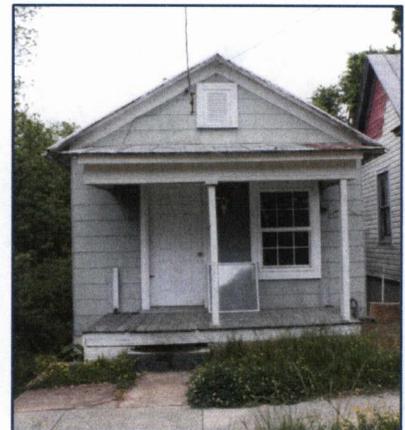
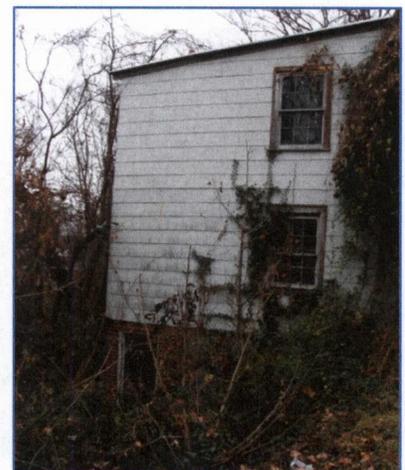
644 Cabell Street (Front & Side)

The result of these significant slopes is a disinvestment in many of the homes situated on a parcel directly impacted by a severe slope. While many well-to-do or resort communities where property values are high contain homes on severe

slopes, maintaining a slope-impacted home in a low- and moderate-income community where the homes were modestly built in the late 1800's or early 1900's and the housing values are very low makes less economic sense. As an example, 644 Cabell St. (shown on the previous page) appears to be a small one-story bungalow at first glance. In reality, because of the slope of the lot, the house quickly becomes a two-story house and is ultimately a three-story house at the back wall of an addition, where an exposed basement was converted to liveable space at some time in its history.

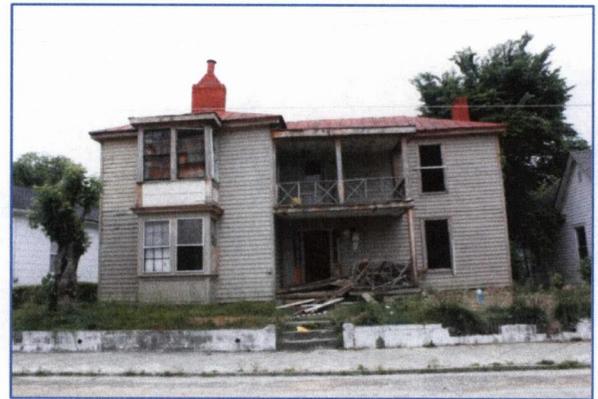
714 Colquhoun Street (recently demolished)

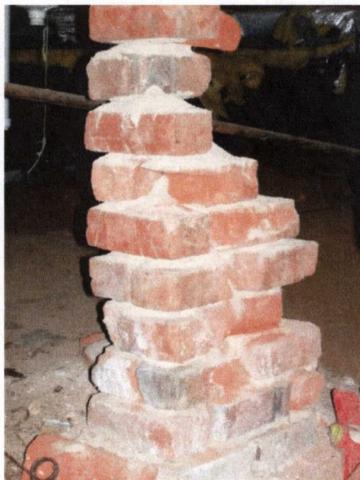
Interior pier at 530 Cabell Street

Many of the problems noted by CPP staff and Mr. Dunbar are not necessarily noticed on a quick drive-by inspection. One property, by all exterior appearances, had been stabilized with a new foundation. When looking in the crawl space, it

was quickly evident that the exterior and interior supporting piers were still in trouble with one interior pier under a main support beam held together by a single brick (see picture on previous page). On further inspection of other houses, the deteriorating piers were found to be a significant problem threatening the

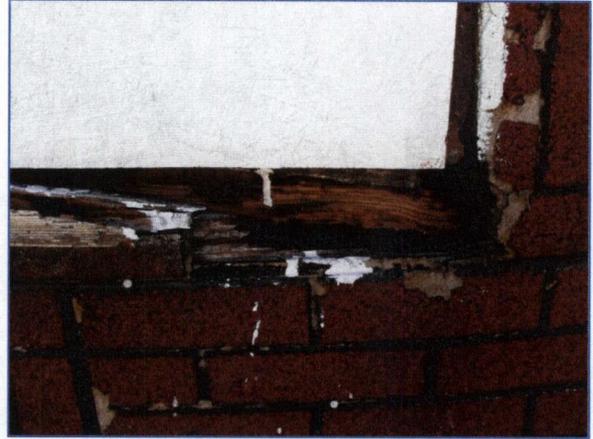
Example of Deteriorated Window Framing

structural integrity of many of the buildings. Other properties had various types of siding applied, but from the inside it was quite obvious that in many cases the wall studs had significant water and termite damage to the point of losing their structural integrity. For the houses in the worst condition, this was also true of floor joists, sill plates, and the framing around door and window openings (as shown on this page).

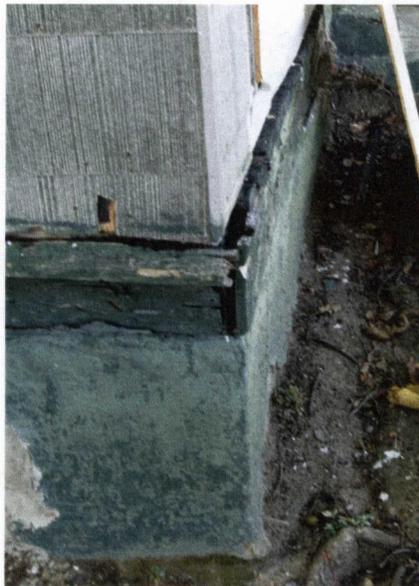
Example of a Rotten Sill Plate

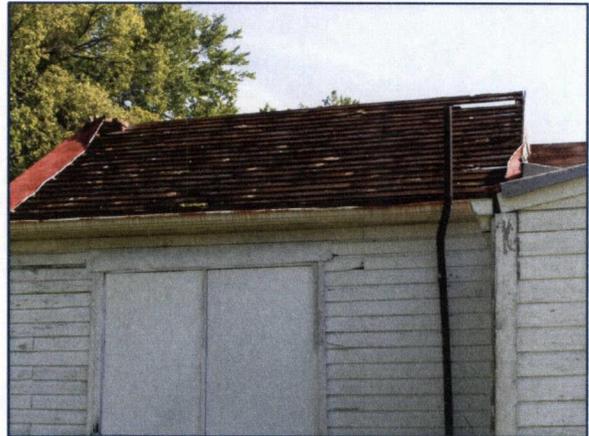
One of the biggest problems currently facing the neighborhood is that individuals are breaking into the vacant structures to strip them of any replacement windows or other newer elements and stealing metal roofing, plumbing fixtures, window sash weights, etc. This has left many already deteriorated buildings open to the elements and therefore damaging them more. The City has worked with its Police Department to step up patrols, even marking the houses

The Metal Roofing Was Stripped from this House to Sell to a Scrap Dealer

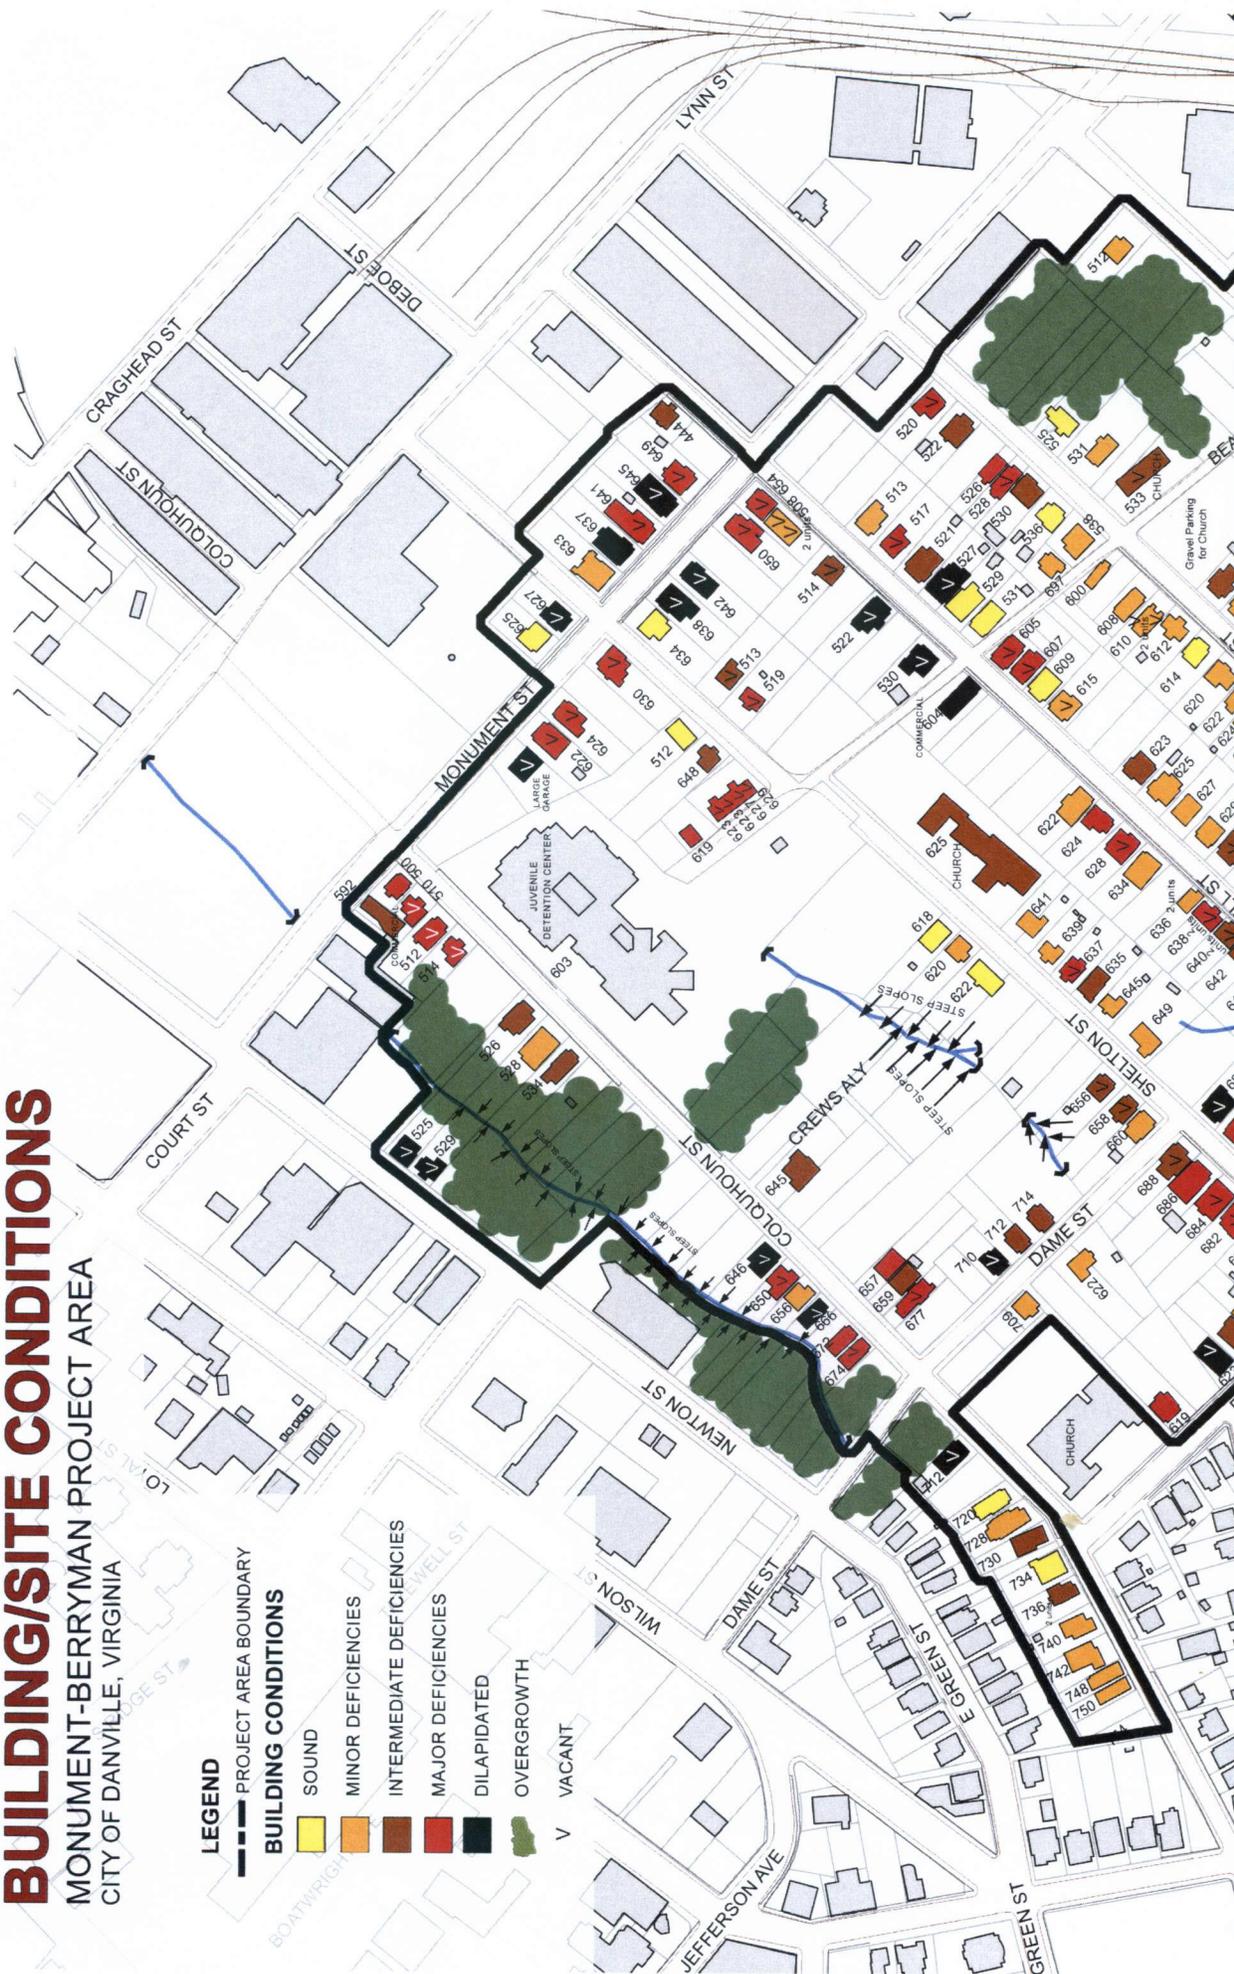
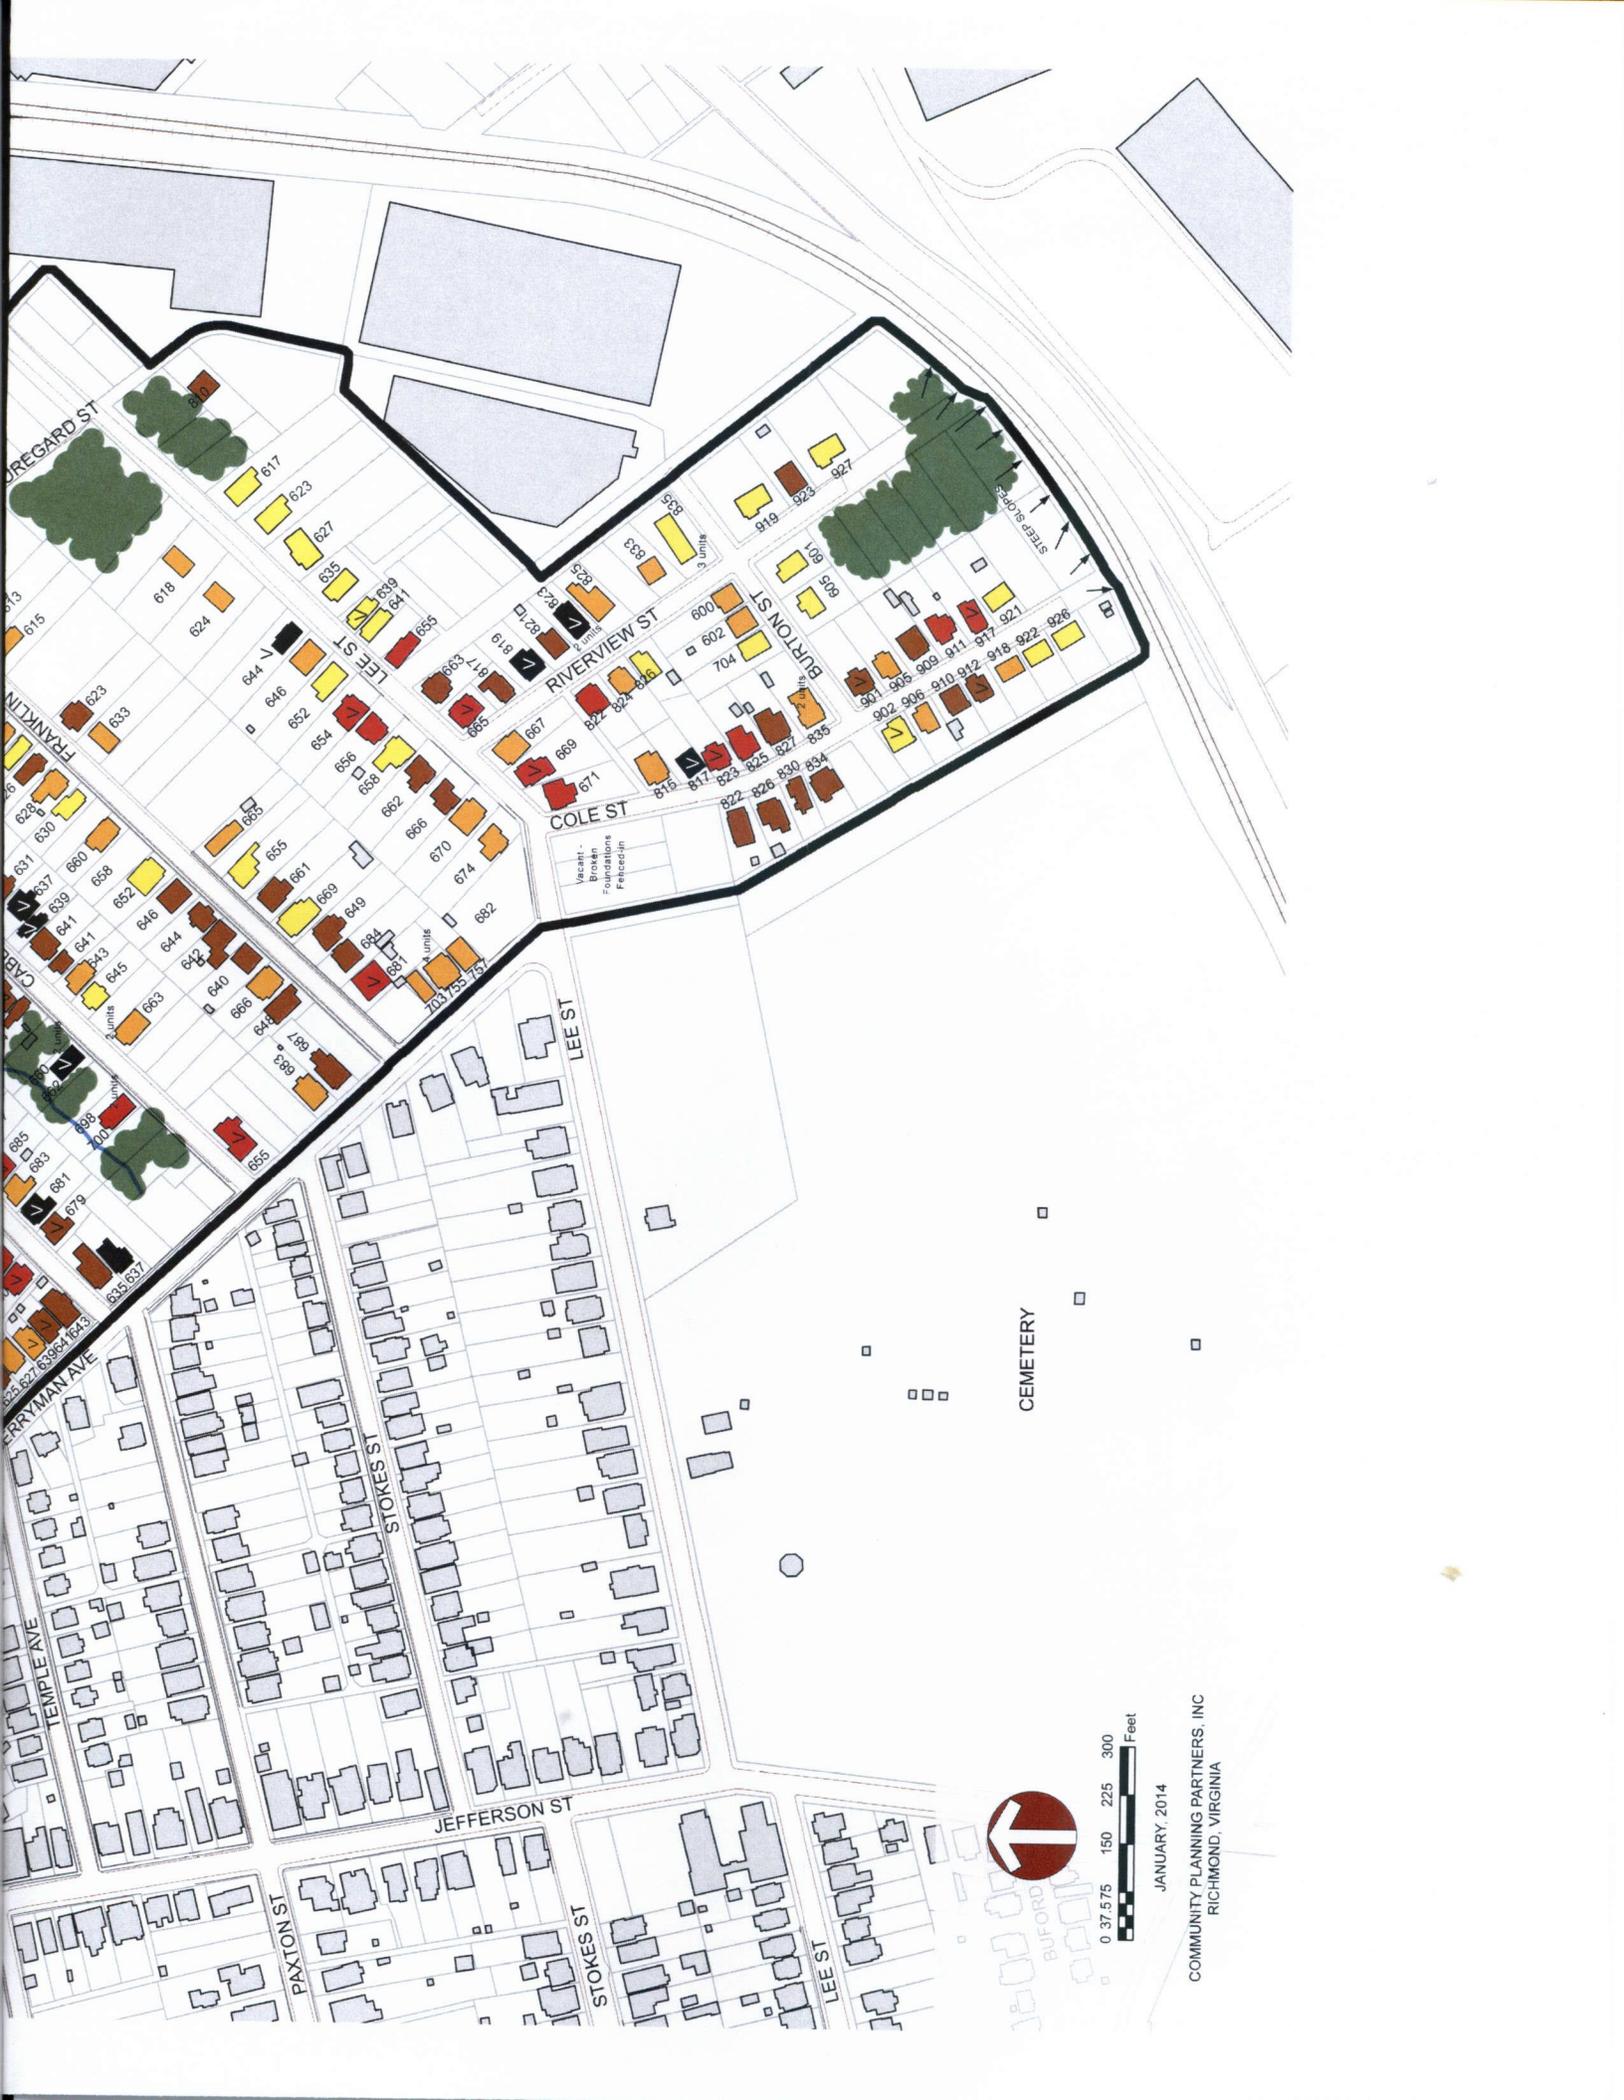
BUILDING/SITE CONDITIONS

After page 10 can be found a Building/Site Conditions Map for the Monument-Berryman Primary Study Area. The building conditions were surveyed and the buildings were photographed by staff of Community Planning Partners (CPP) in April-May 2012 with updates as conditions changed per standards generally utilized by local and state government with conditions ranging from sound (in yellow) to dilapidated (in black). These conditions are based on exterior inspections, but in order to more closely understand the contributing factors for the buildings in the worst condition, CPP staff went on the properties and entered a number of the buildings currently owned by the City of Danville or the Danville Redevelopment and Housing Authority. These interior inspections confirmed that the buildings with major deficiencies or that are dilapidated deserved the ratings given them during the exterior survey. The inspections also served to inform the Consulting Team as to conditions hidden by "quick fixes" that have been applied to many of the buildings over the years.

Of the 243 buildings with 262 units (residential, commercial, churches), **91 of the units (34.7%) have major deficiencies or are dilapidated.** Structures with major deficiencies have sufficient enough deficiencies that it may not be economically feasible to rehabilitate them and they are therefore quickly moving toward a condition where clearance can not be avoided. Dilapidated structures are those that clearly require clearance due to loss of structural integrity or are so structurally unsound that rehabilitation is likely to be economically infeasible leaving demolition as the only alternative. The conditions included in the previous table are also shown via a Building/Site Conditions Map that follows this page.

- LEGEND**
- PROJECT AREA BOUNDARY
 - BUILDING CONDITIONS**
 - SOUND
 - MINOR DEFICIENCIES
 - INTERMEDIATE DEFICIENCIES
 - MAJOR DEFICIENCIES
 - DILAPIDATED
 - OVERGROWTH
 - V VACANT

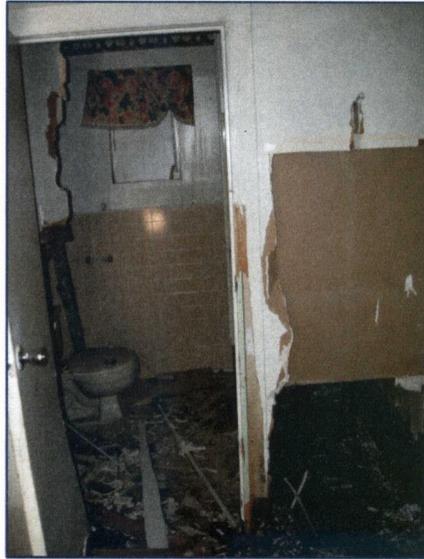
The Old Tub Was Stolen from this House for its Cast-Iron

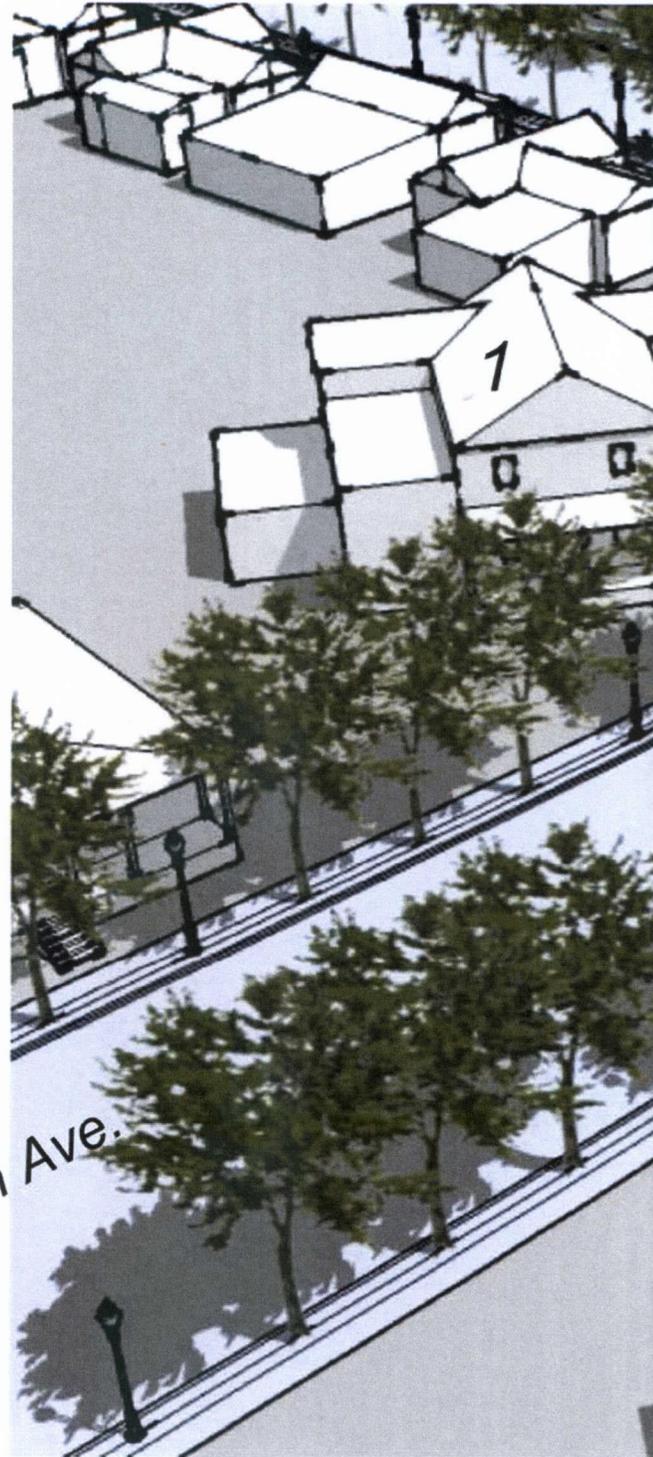
Concept - Lee at Berryman

1. New Homes
2. Street Lights
3. Sidewalks
4. Street Trees
5. Green Hill Cemetery
6. Laneway
7. Crosswalks

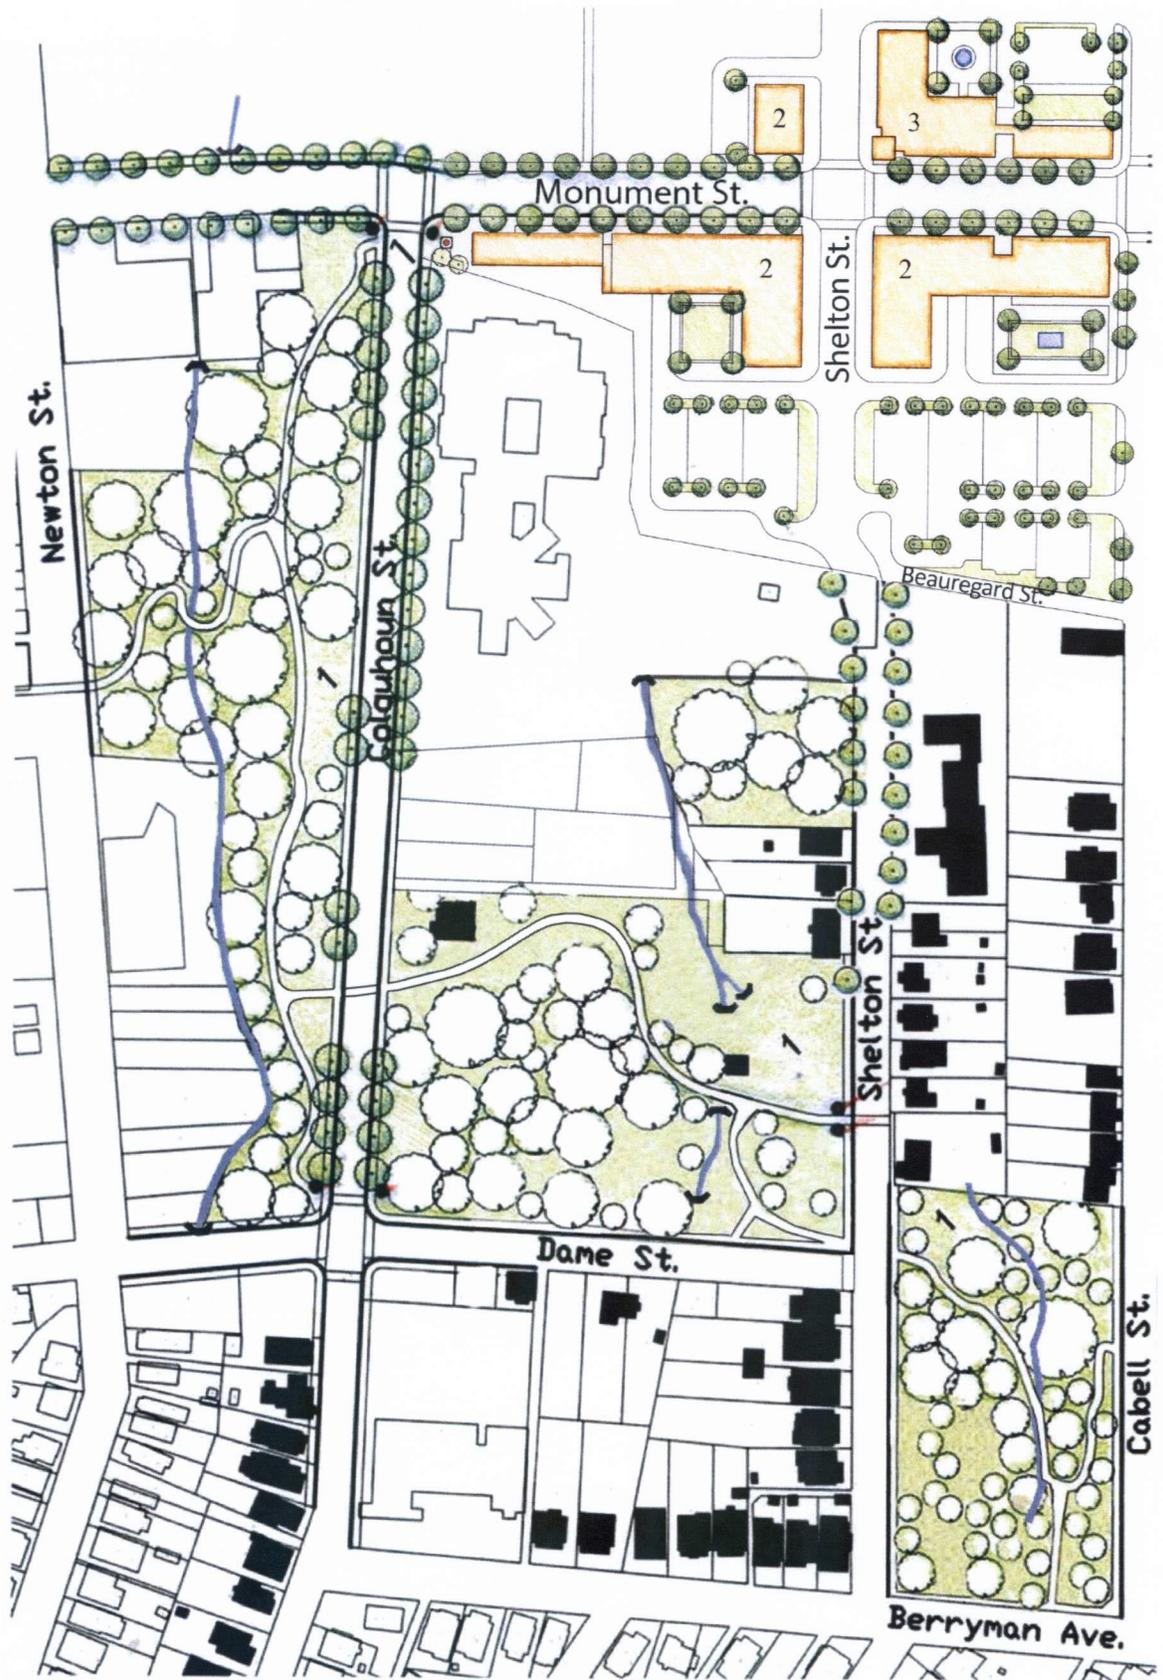
Illustrative Neighborhood Site Plan - (Open Space)

The single home shown remaining on the east side of Colquhoun St. is a substantial home in good condition. It has been left here to illustrate the possible location of the "From Farm to Factory" Living History Center mentioned on pages 23-24.

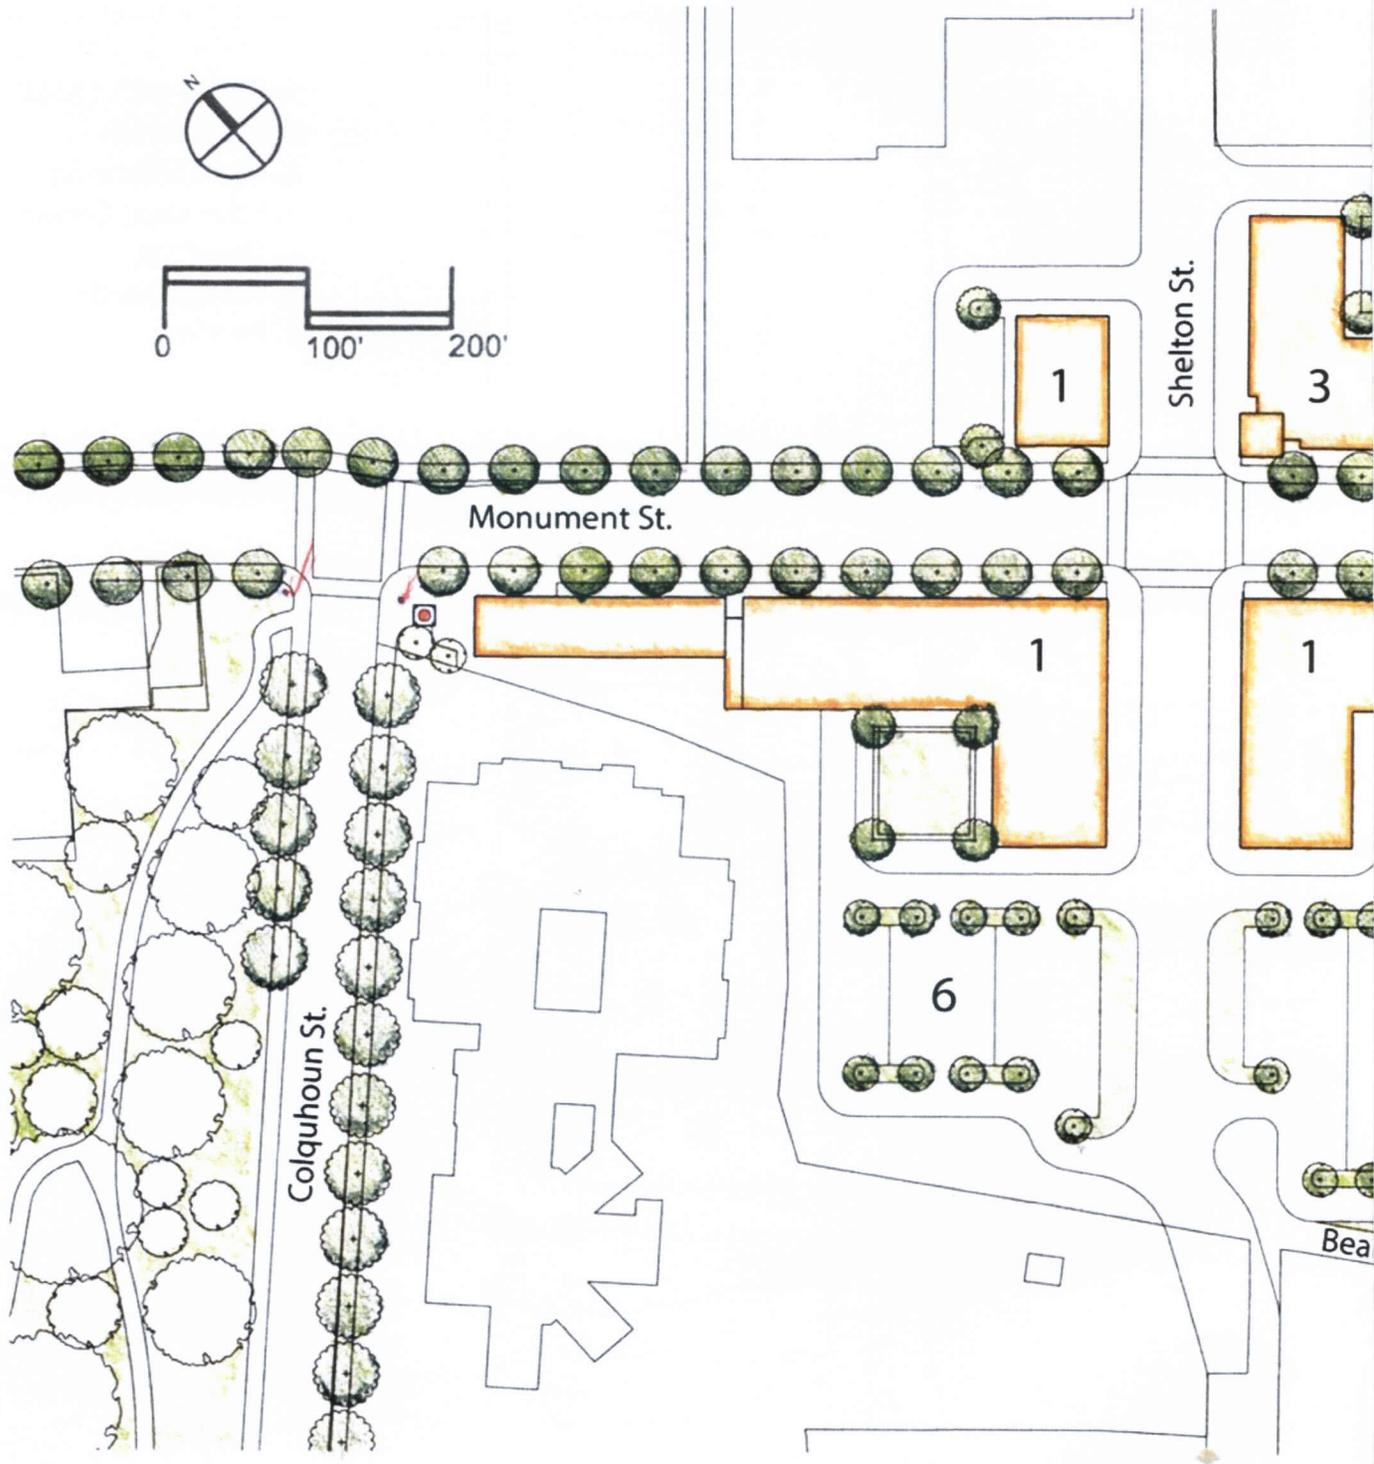
Illustrative Neighborhood Site Plan - (Monument Street)

- An entrance gateway to the open space that would be developed along Colquhoun, Shelton, and Cabell Streets.
- A mix of on-street and off-street parking sufficient to meet the demands of the new development and maintain appropriate traffic flow.

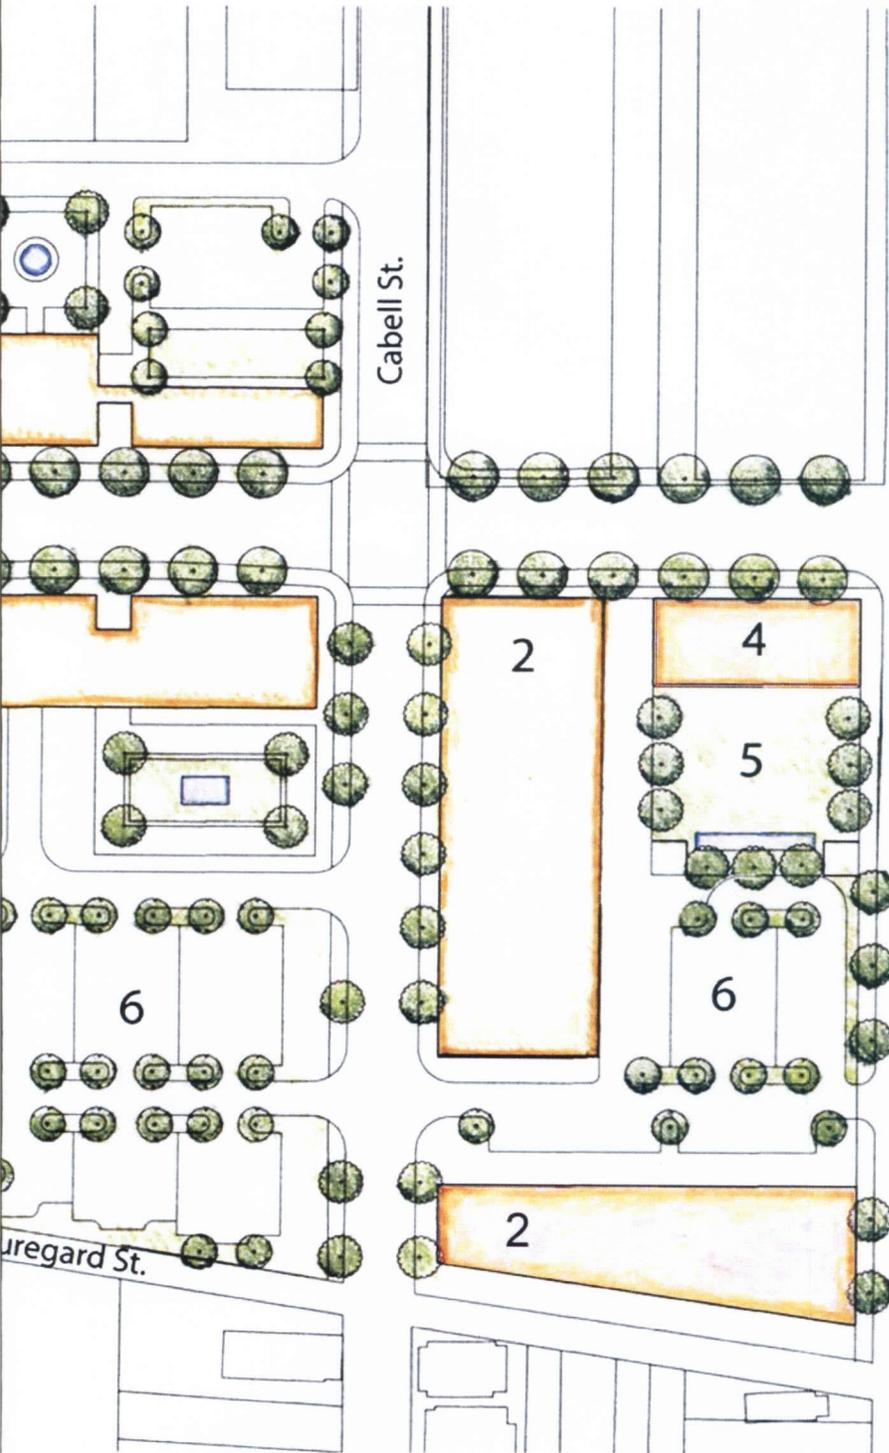
1. Office with Local Serving Retail
2. Light Industrial
3. Education Center
4. Day Care
5. Play Ground
6. Parking

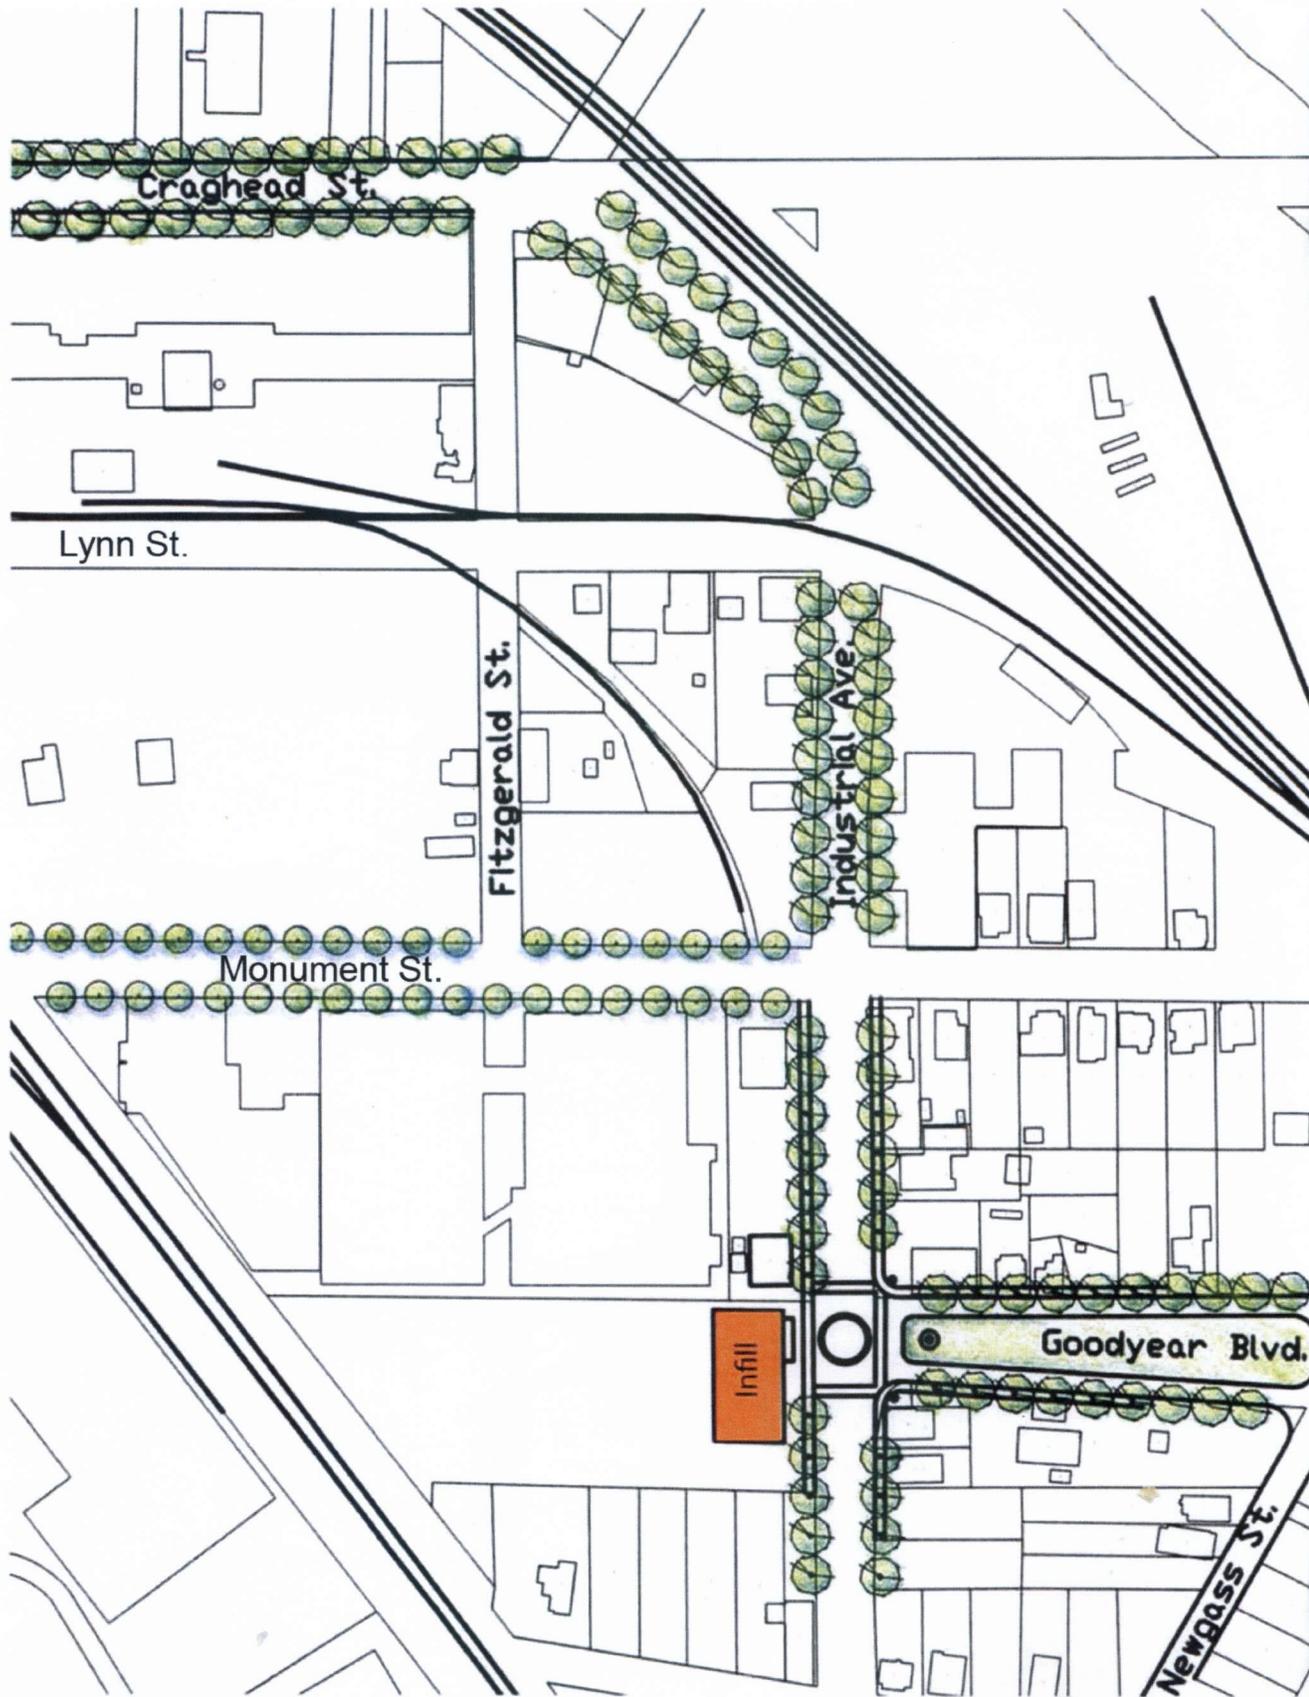
Illustrative Neighborhood Site Plan - (Gateway Site)

The site plan also shows an infill building just west of the Goodyear/Industrial intersection. This currently vacant lot would not serve well as a backdrop to a major gateway/welcoming point for the City, hence a new building is shown.
